Network Operating Center Electric System Study

Hopkinsville, KY

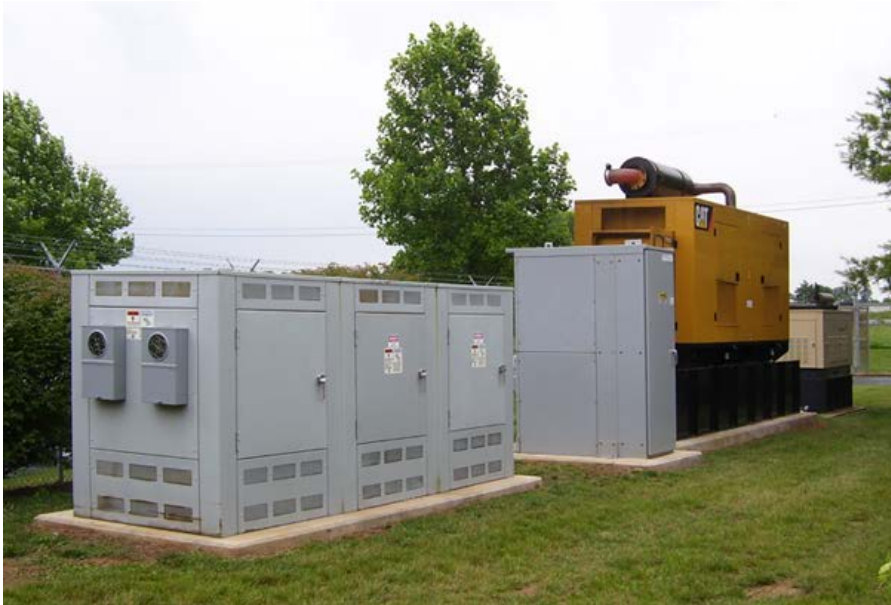
NOC's outside emergency generator

The primary cause of the lightning damage appeared to be lightning-induced voltage transients into the low-voltage circuit conductors between the outdoor generator and the NOC. Puckett Engineering recommended additional grounding and bonding, surge protection, and other enhancements to improve the reliability of their NOC's critical electrical infrastructure. Additional recommendations included preventative maintenance and periodic re-commissioning.

Puckett Engineering made recommendations for protecting system from future strikes and other power irregularities
