CASE STUDY

Lightning Strike Study for Gladeville Baptist Church Gladeville, TN

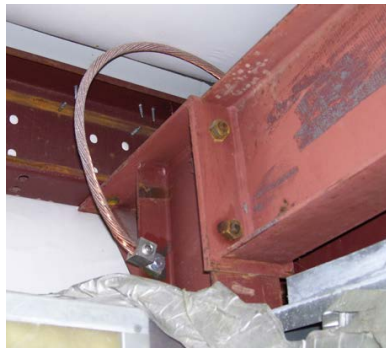
Bonding jumper installed
between buildings

Recommended bonding the grounding systems together, isolating data and communication circuits, and adding surge protection.
